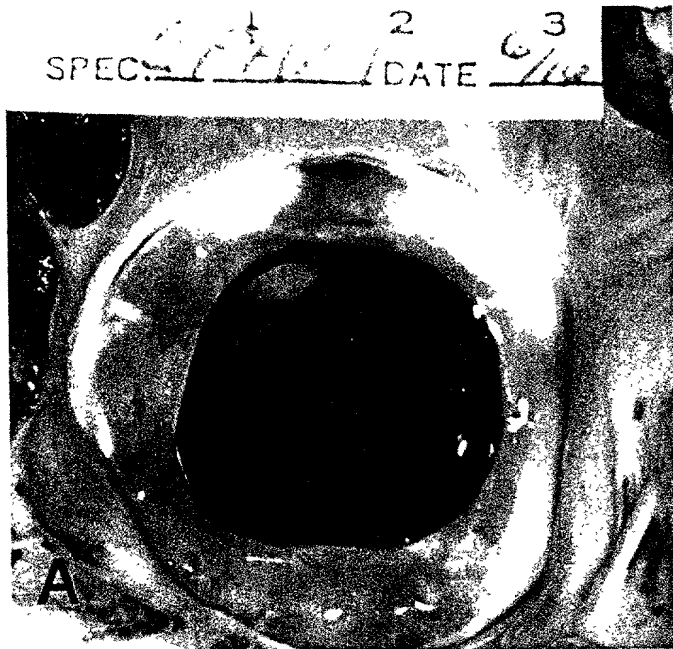
Figure 4. Color photograph of an untreated control heart valve (CPHV-1) explanted after 90 days in the mitral position of a juvenile sheep heart.

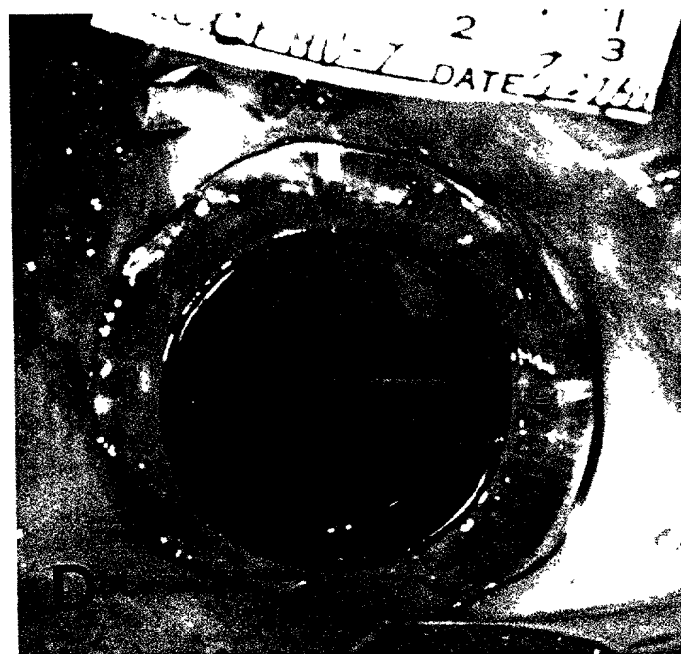
Figure 5. Color photograph of a heart valve (CPHV-7) treated according to the present invention explanted after 90 days in the mitral position of a juvenile sheep heart from the same implant study as the valve of Figure 3.
